Manhole Inspection Summary

Manhole # S21E__006MH

Insp Date: **8/16/07 12:06 PM**

Location Address: **301 FULTON-BRUCE**

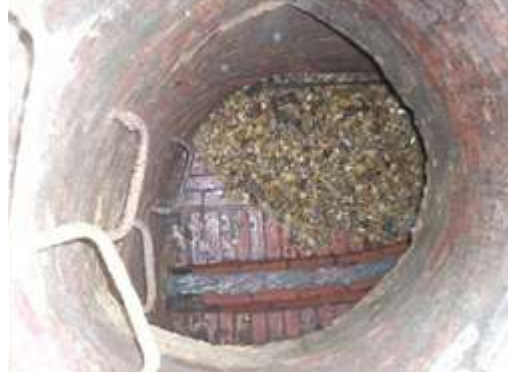
Top View

DEBRIS ON BENCH AND IN CHANNEL

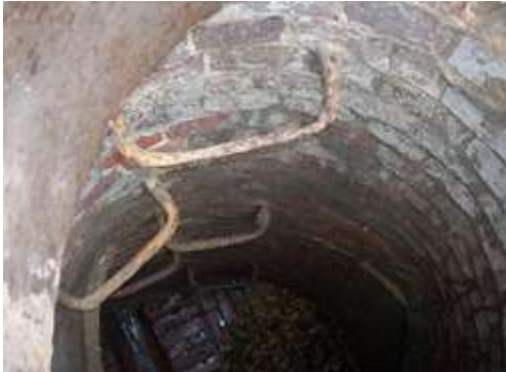
Defect 2

Steps Count: **5** Missing: **0** ☒ **Corroded**

CORRODED STEPS

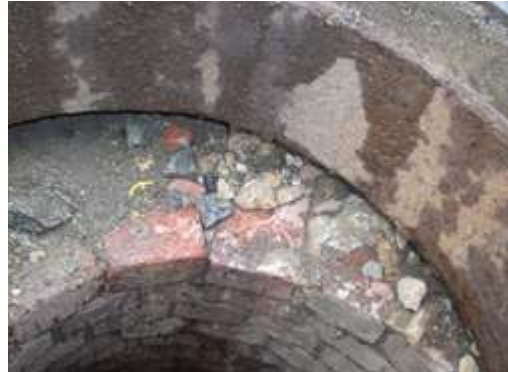
Defect 1

Frame Offset: **8** (in.) Condition: ☒ Sound ☐ Cracked ☐ Leaks

FRAME OFFSET

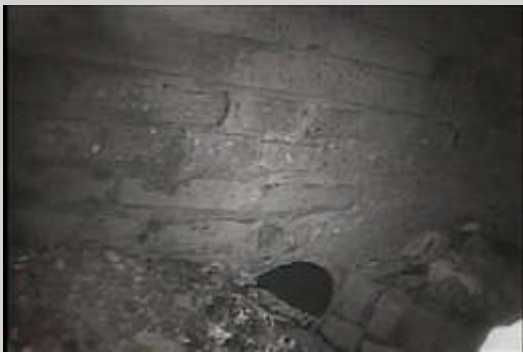
12 O'Clock Outflow

8 in. Circular Gravity Sewer
Pipe Out @ 12 O'Clock

Pipe Height: **7.2** (in.) Rod and Bar (Angled)
Pipe Material: **Clay** ☐ Pipe Lined
Invert Depth: **9.20** (ft.) Flow Characteristics: **Slow**
Deposits: ☒ None ☐ Mud ☐ Sludge ☐ Debris ☐ Grease
Silt Depth: (in.) Deposits Extent:
Infiltration: **None** Pipe Seal Cond: **Sound**

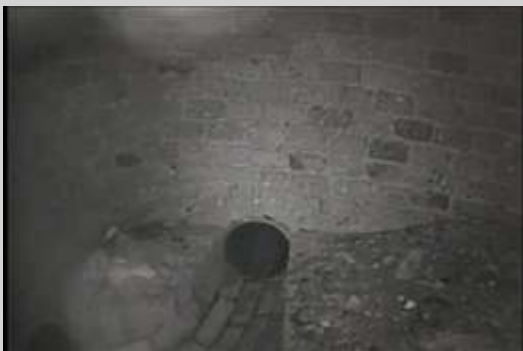
3 O'Clock Inflow

8 in. Circular Gravity Sewer
Pipe In @ 3 O'Clock

Pipe Height: **8.4** (in.) Rod and Bar (Angled)
Pipe Material: **Clay** ☐ Pipe Lined
Invert Depth: **8.99** (ft.) Flow Characteristics: **Slow**
Deposits: ☒ None ☐ Mud ☐ Sludge ☐ Debris ☐ Grease
Silt Depth: (in.) Deposits Extent:
Infiltration: **None** Pipe Seal Cond: **Sound**

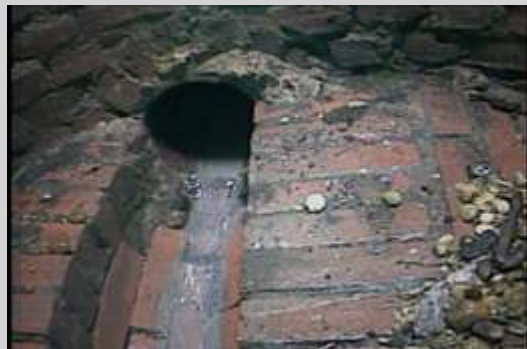
9 O'Clock Inflow

8 in. Circular Gravity Sewer
Pipe In @ 9 O'Clock

Pipe Height: **8.4** (in.) Rod and Bar (Angled)

Infiltration: **None** Pipe Seal Cond: **Sound**
